WISCONSIN FACE INVESTIGATION

SUBJECT: Farmer Fell into Auger of Manure Spreader while Scraping the Tank

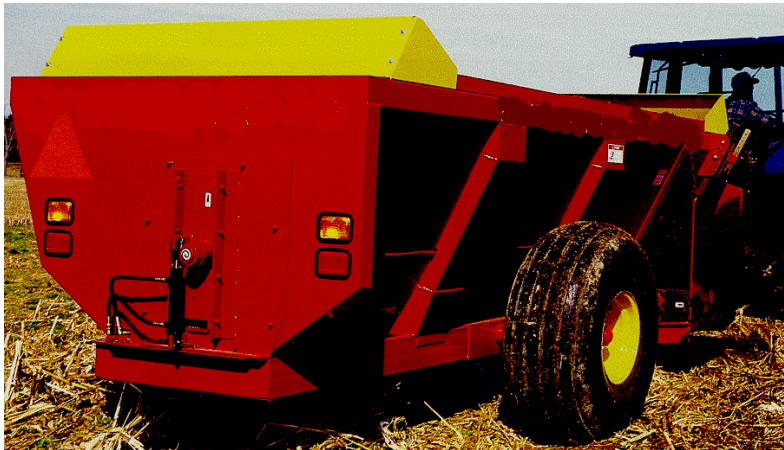
Figure 1. V-tank design side-delivery spreader

On February 27, 2003 a 38 year-old farmer died when he fell into a manure spreader and was pulled into the auger. The victim was working by himself cleaning the sides of the spreader tank with a scraper, while standing on the front tire of the spreader (Figure 1). He didn't return to the farm at the usual time so a co-worker went out to the field and found the victim under the auger at approximately 7:30 AM. The co-worker called for emergency services located about 14 miles away. The victim was pronounced dead at the scene. The spreader was transported to a facility where the body could be extricated.

*Height from ground to
top of tank: 5 feet*

*Victim stood on a tire to
scrape the inside of the
tank on a similar spreader.*

Recommendation #1: Remain seated on the tractor while the spreader is in operation.

Discussion: One of the safety precautions the operators manual recommends is: "Do not get off the tractor while the spreader is in operation." The power to the PTO will be off when the engine of the tractor is shut off, preventing the auger from rotating.

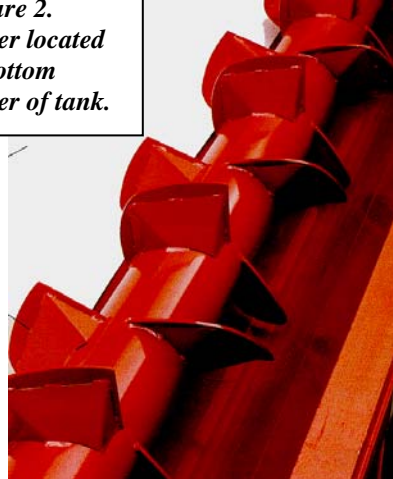
*Figure 2.
Auger located
in bottom
center of tank.*

On the day of the incident, the victim went to the neighbor's farm and cleaned the barn. The victim had planned to bring a calf to his home farm later that morning. He talked with his co-worker at the neighbor's farm before he left to take a load of manure out to the field. When the co-worker thought he had been gone longer than usual, he went to the field to check on him. At that time the co-worker found the victim in the spreader under the auger. The victim had been working by himself cleaning the sides of the spreader tank with the scraper, while standing on the front tire of the spreader. He apparently fell into the spreader and was caught under the auger (Figure 2). In freezing

While it appeared that the victim slowed the power take off on the tractor, he did not turn it off when he went back to clean the manure spreader. When the power take off is running at full speed, the auger which is located in the center of the machine pushes the manure up front and then beaters at the door of the chute kick the manure out the side up to a distance of 20 feet. At the time of the incident, the manure had been kicked out approximately a distance of 8-10 feet, demonstrating that the tractor was running slowly. When the victim was caught in the auger, the tractor lost power and shut off; however, the key was turned on and the ignition red light on the dashboard of the tractor was activated at the time the victim was discovered. The sides of the spreader had about 3 feet of manure left to clean when the victim fell into the spreader.

Auger Dimensions:

***Diameter: 24 in.
Length: Approx: 16 ft.***

Recommendation #2: Stop all augers and shut off the power source before operators attempt to clean, maintain or work close to the auger.

Discussion: Because many manure spreader augers are not shielded, augers should be stopped prior to operators performing any activities in the vicinity of the auger. This

includes cleaning the sides of the spreader and any other activities that place an individual close enough to an auger that entanglement might occur. If the auger involved in this incident had been shut off, this fatality would have been prevented. The operator's manual states "Do not clean, lubricate, or make any adjustments to the spreader while it is in motion or operation."
